Hilton Brown - 2 x Swimming Pools

Hilton Brown Pools use the Airius system in two of their five recreational and competitive swimming pools to combat all these problems (and more!) and have already made arrangements to install Airius into another two.

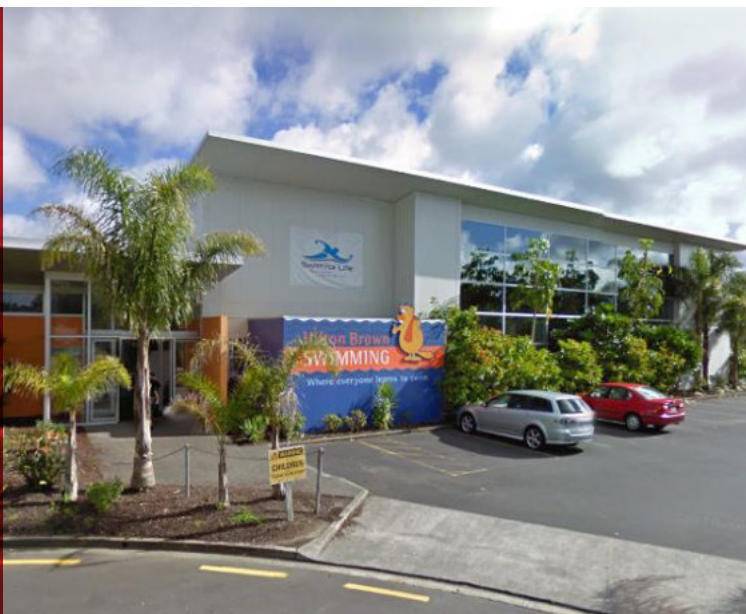
For the Albany pool, which measured approximately 20 metres by 12 metres, the Airius Standard Series model 60 was specified. In the changing room the smaller Standard Series model 15 was recommended.

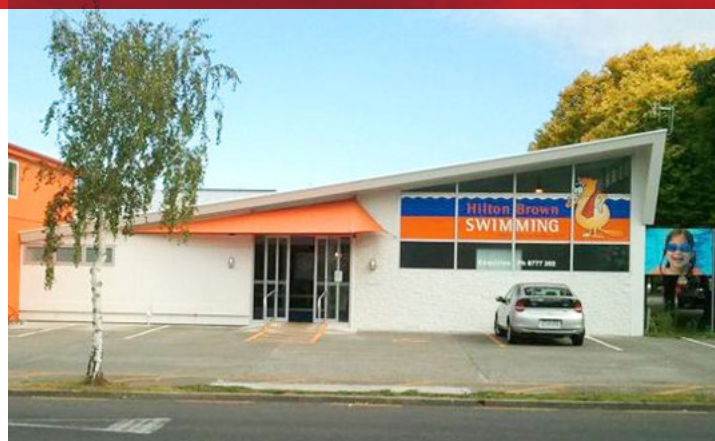
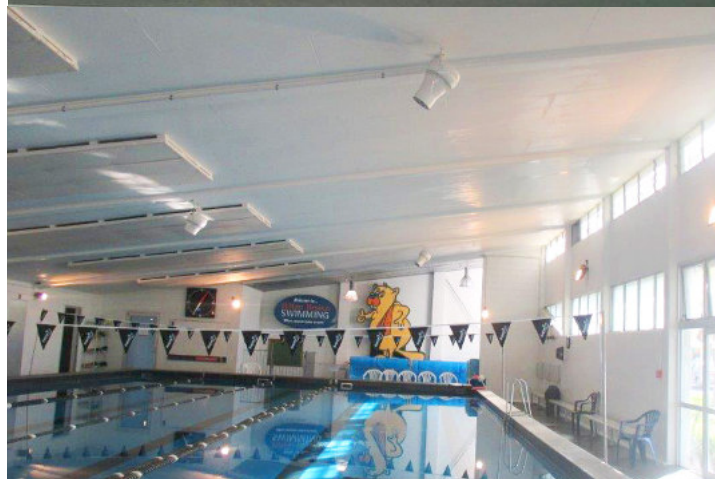
The Havelock North pool, due to its sloped roof, required Standard Series model 25 and 15 units, to account for the variation in height. At its highest point the ceiling was 4.8 metres and the pool measured 24 metres long by 14 metres wide.

After installation both sites virtually eliminated all condensation. Any signs of damp quickly subsided and surfaces dried much faster. Even the concrete, which had become saturated and discoloured, dried out. Comfort levels vastly improved and within only two days the unpleasant odours were almost non-existent.
